**Flood Control Project Maintenance  
Levee Inspections**

**Fall 2018 Levee Maintenance Deficiency Summary Report**

**Sacramento River Basin**

**Butte County Department of Public Works**

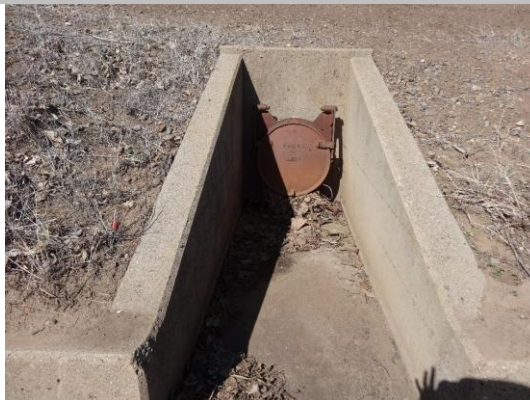
Photo 1 of 3 : UCIP\_FA\_2018\_32044\_58543.jpg

LM Start	1.00	Rating **	M	Issue No.	60	
LM End	1.00	Issue Type +	Ma	Location *		
Category	Supplemental			GPS Latitude/Longitude		
				Start		End
Item	DWR UCIP LMA Responsibility			39.739268 °		39.739268 °
				-121.931891 °		-121.931891 °
DWR ID	19211					
Comment Code						
Inspector Comment						
FS_ID:32044						
DS_ID:19211						
EP_NO: N/A						
Repair Type: Non-Urgent						
Crossing Status: Found						
UCIP Comments: Vegetation debris on waterside. Needs clearing and cleaning.						
FIELD_STRUCT_DESC: 24-inch corrugated metal gravity drainage pipe through the levee, 12 feet below the crown. Flap gate on the waterside (WS) end. Concrete U-shaped headwall on each end. Grouted riprap apron on the landside (LS) end. Grouted riprap spillway on the WS end. [Additional Reference(s): DWR Levee Log, 1992. USACE Sacramento O&M Manual 504, May 1965, (HLM 1.03)].						
FS Date: 2/20/2014

WS view: U typed concrete headwall, pipe, and flapgate on levee slope.

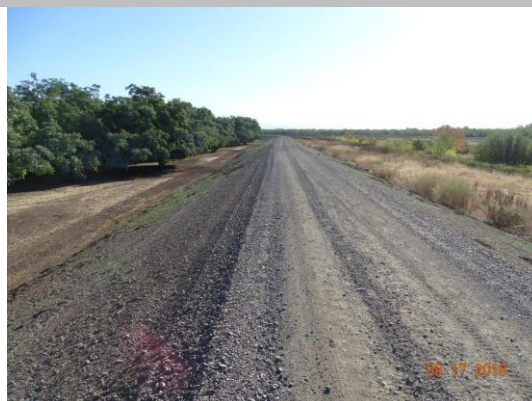
Photo 1 of 1 : FA\_2018\_NA0003\_64\_26\_20181001\_00065.jpg

LM Start	1.06	Rating **	A	Issue No.	26
LM End	1.06	Issue Type +	Ma	Location *	LS
Category	Earthen Levee			GPS Latitude/Longitude	
				Start	End
Item	Vegetation			39.739590 °	39.739590 °
				-121.930827 °	-121.930827 °
DWR ID	DWR_NA0003_01_f_2018_26				
Comment Code					
V1 : Control annual grass and weeds on the levee slopes and easements.					
Inspector Comment					
There is no vegetation on both slopes.

View of the levee with no vegetation on both slopes.

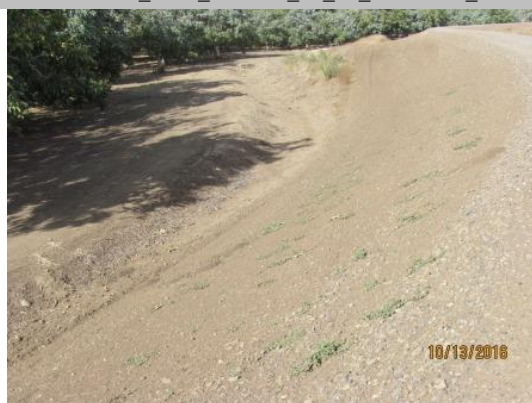
Photo 1 of 1 : FA\_2018\_NA0003\_64\_46\_20180905\_00023.jpg

LM Start	1.19	Rating **	M	Issue No.	46
LM End	1.25	Issue Type +	En	Location *	LS
Category	Earthen Levee			GPS Latitude/Longitude	
				Start	End
Item	Encroachments			39.740082 °	39.740697 °
				-121.928383 °	-121.927844 °
DWR ID	DWR_NA0003_01_f_2016_46				
Comment Code					
DT : Ditch					
Inspector Comment

View of a ditch along the toe.

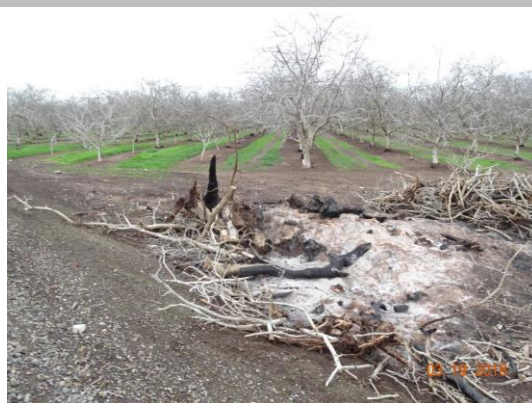
Photo 1 of 1 : FA\_2018\_NA0003\_64\_15\_20180905\_00003.jpg

LM Start	1.69	Rating **	M	Issue No.	15
LM End	1.69	Issue Type +	En	Location *	LS
Category	Earthen Levee			GPS Latitude/Longitude	
				Start	End
Item	Encroachments			39.745718 °	39.745718 °
				-121.923124 °	-121.923124 °
DWR ID	DWR_NA0003_01_s_2014_15				
Comment Code					
PR : Prunings					
Inspector Comment					
Remove the prunings from the landside toe

View of the prunings along the landside toe.

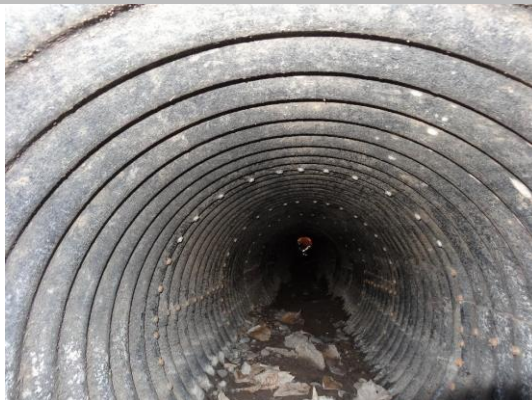
Photo 3 of 3 : UCIP\_FA\_2018\_50142\_55884.jpg

Comment Code						
Inspector Comment						
FS_ID:50142 DS_ID:19212 EP_NO: N/A Repair Type: No Action Needed Crossing Status: Found UCIP Comments: 08/29/2016: Shawn Bates of NA0003 has cleared the LS and WS of debris and blockage; WS gate functions properly now. Crossing has been downgraded from Urgent to No Action Needed. (K. Fazel - UCIP)08/11/2016: Same as last inspection. (K. Fazel - UCIP)02/20/2014:No riprap spillway on waterside. Needs cleaning and clearing of debris. Flap gate was not fully closed. (P. Amatya - UCIP) FIELD_STRUCT_DESC: 24-inch corrugated metal gravity drainage pipe through the levee, 13 feet below the crown. Flap gate on the waterside (WS) end. Concrete U-shaped headwall on each end. Grouted riprap apron on the landside (LS) end. Grouted riprap spillway on the WS end. [Additional Reference(s): DWR Levee Log, 2005. USACE Sacramento O&M Manual 504, May 1965, (HLM 1.95)]. FS Date: 8/11/2016

LS view: inside view of CMP on levee slope. Needs cleaning and clearing.

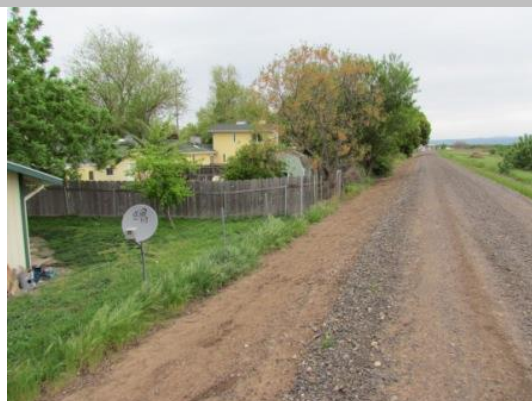
Photo 1 of 1 : FA\_2018\_NA0003\_64\_3\_20180905\_00002.jpg

LM Start	2.00	Rating **	M	Issue No.	3
LM End	2.04	Issue Type +	En	Location *	LS
Category	Earthen Levee			GPS Latitude/Longitude	
				Start	End
Item	Encroachments			39.748330 °	39.748867 °
				-121.918685 °	-121.918533 °
DWR ID	DWR_NA0003_01_s_2012_3				
Comment Code					
FE : Fence					
Inspector Comment

View of the fences along the landside toe.

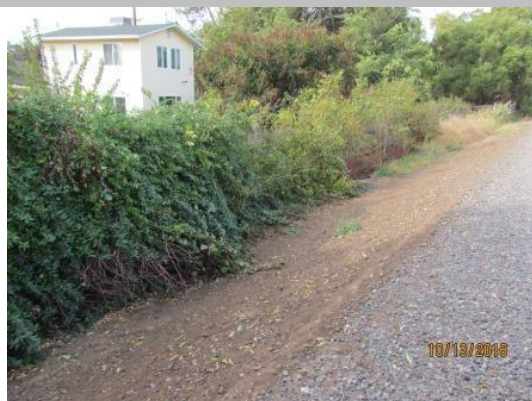
Photo 1 of 1 : FA\_2018\_NA0003\_64\_48\_20180905\_00024.jpg

LM Start	2.03	Rating **	M	Issue No.	48
LM End	2.11	Issue Type +	En	Location *	LS
Category	Earthen Levee			GPS Latitude/Longitude	
				Start	End
Item	Vegetation			39.748784 °	39.749872 °
				-121.918597 °	-121.918296 °
DWR ID	DWR_NA0003_01_f_2016_48				
Comment Code					
V6 : Landscaping					
Inspector Comment

View of landscaping vegetation blocking visibility.

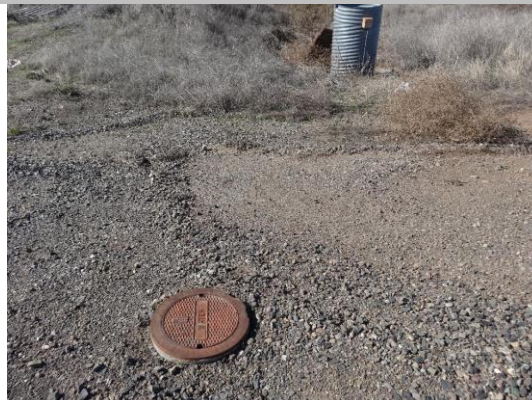
Photo 1 of 3 : UCIP\_FA\_2018\_30291\_55700.jpg

FS\_ID:30291  
DS\_ID:19230  
EP\_NO: 16633  
Repair Type: Non-Urgent  
Crossing Status: Indicator Found  
UCIP Comments: A concrete water control box on landside shoulder. It needs confirmation and more info from LMA and/or DWR Inspector.  
FIELD\_STRUCT\_DESC: 2-inch coated and wrapped steel storm water discharge pipeline through the right bank and landside (LS) levee toe of Mud Creek. Submerged pump in a 36-inch corrugated metal pipe (CMP) casing, approximately 10 feet from the LS toe. Drainage ditch, up to 4 feet wide, runs perpendicular to the levee alignment starting at a CMP riser and running away from the levee. (Plans to install a 2-inch storm water discharge pipe through the levee and a pump on a concrete base on the right bank LS levee toe of Mud Creek authorized under Permit No. 16633, 1996 - Jim Paiva).  
FS Date: 2/20/2014

LS view: CMP riser on levee toe (top) and control box on levee shoulder (bottom).

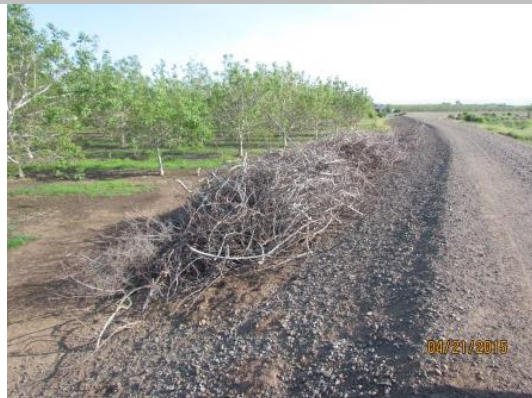
Photo 1 of 2 : FA\_2018\_NA0003\_64\_31\_20180905\_00012.jpg

LM Start	3.15	Rating **	M	Issue No.	31 (cont)
LM End	3.15	Issue Type +	En	Location *	LS

View of the prunings along the landside slope.

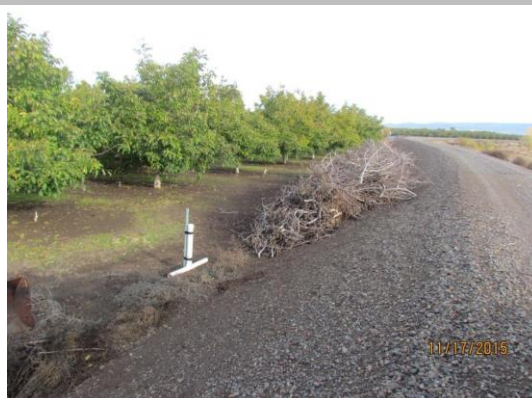
Photo 2 of 2 : FA\_2018\_NA0003\_64\_31\_20180905\_00013.jpg

View of the prunings and bait station along the landside slope.

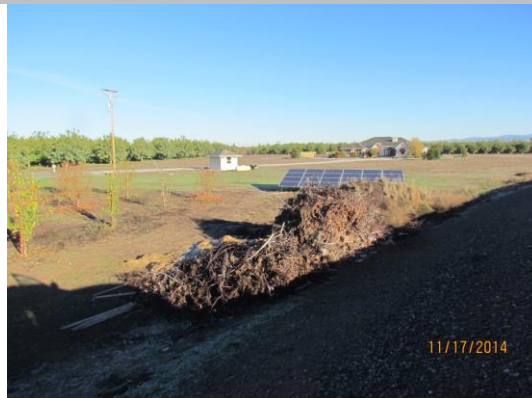
Photo 1 of 1 : FA\_2018\_NA0003\_64\_27\_20180905\_00008.jpg

LM Start	3.25	Rating **	M	Issue No.	27
LM End	3.25	Issue Type +	En	Location *	LS
Category	Earthen Levee			GPS Latitude/Longitude	
				Start	End
Item	Encroachments			39.763993 °	39.763993 °
				-121.909108 °	-121.909108 °
DWR ID	DWR_NA0003_01_f_2014_27				
Comment Code					
PR : Prunings					
Inspector Comment					
Remove the prunings from the landside slope.

View of the prunings along the landside toe.

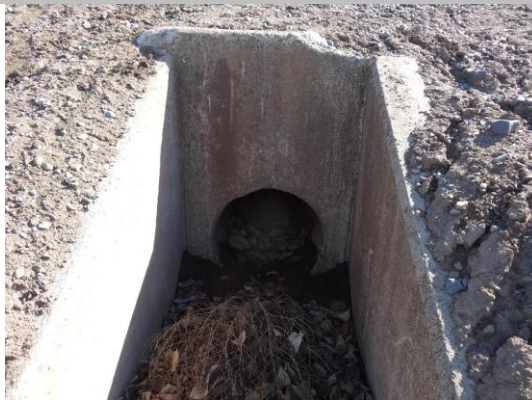
Photo 2 of 3 : UCIP\_FA\_2018\_30310\_55740.jpg

LM Start	3.39	Rating **	M	Issue No.	65 (cont)	
LM End	3.39	Issue Type +	Ma	Location *		
Category	Supplemental			GPS Latitude/Longitude		
				Start		End
Item	DWR UCIP LMA Responsibility			39.765440 °		39.765440 °
				-121.907261 °		-121.907261 °
DWR ID	19218					
Comment Code						
Inspector Comment						
FS_ID:30310 DS_ID:19218 EP_NO: N/A Repair Type: Non-Urgent Crossing Status: Found UCIP Comments: Needs cleaning and clearing of debris. FIELD_STRUCT_DESC: 24-inch corrugated metal gravity drainage pipe through the levee, 10 feet below the crown. Flap gate on the waterside (WS) end. Concrete U-shaped headwall on each end. Grouted riprap apron on the landside (LS) end. Grouted riprap spillway on the WS end. [Additional Reference(s): DWR Levee Log, 1992. USACE Sacramento O&M Manual 504, May 1965, (HLM 3.48)]. FS Date: 2/20/2014

LS view: U type concrete headwall and CMP on levee slope.

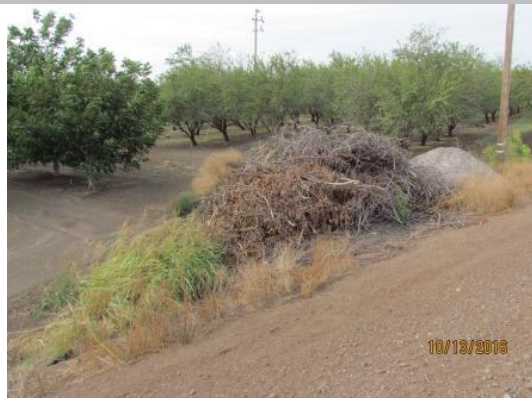
Photo 1 of 1 : FA\_2018\_NA0003\_64\_50\_20180905\_00027.jpg

LM Start	3.70	Rating **	M	Issue No.	50
LM End	3.70	Issue Type +	En	Location *	LS
Category	Earthen Levee			GPS Latitude/Longitude	
				Start	End
Item	Encroachments			39.767920 °	39.767920 °
				-121.902520 °	-121.902520 °
DWR ID	DWR_NA0003_01_f_2016_50				
Comment Code					
PR : Prunings					
Inspector Comment					
Remove prunings from the landside toe.

View of the prunings along the landside toe.

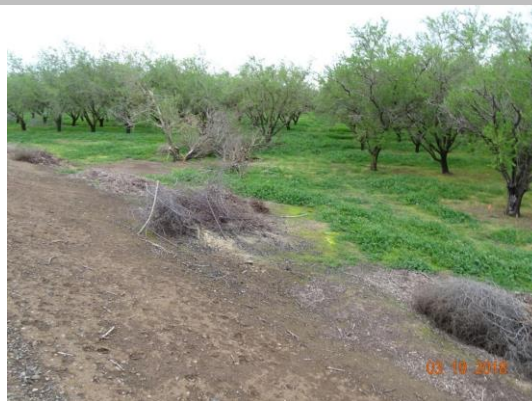
Photo 1 of 1 : FA\_2018\_NA0003\_64\_32\_20180905\_00014.jpg

LM Start	3.89	Rating **	M	Issue No.	32
LM End	3.89	Issue Type +	Ma	Location *	LS
Category	Earthen Levee			GPS Latitude/Longitude	
				Start	End
Item	Encroachments			39.770395 °	39.770395 °
				-121.901305 °	-121.901305 °
DWR ID	DWR_NA0003_01_s_2018_32				
Comment Code					
PR : Prunings					
Inspector Comment					
Remove the prunings from the landside toe

View of the prunings along the landside toe.

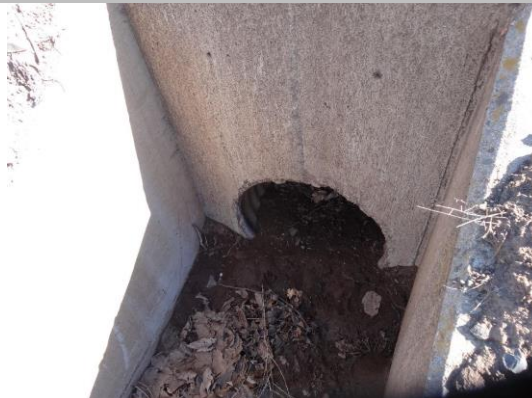
Photo 2 of 2 : UCIP\_FA\_2018\_30311\_55742.jpg

LS view: U type concrete headwall and CMP on levee slope.

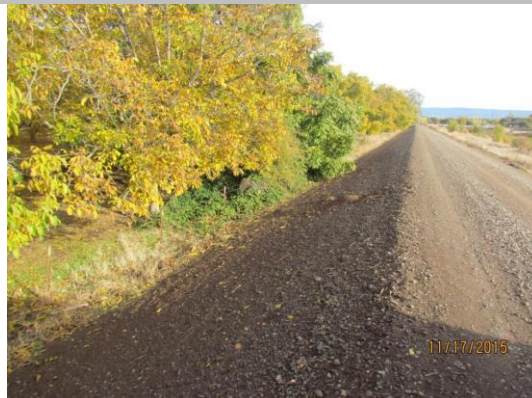
Photo 1 of 1 : FA\_2018\_NA0003\_64\_33\_20180905\_00015.jpg

LM Start	4.27	Rating **	M	Issue No.	33
LM End	4.27	Issue Type +	Ma	Location *	LS
Category	Earthen Levee			GPS Latitude/Longitude	
				Start	End
Item	Animal Control			39.773398 °	39.773398 °
				-121.895765 °	-121.895765 °
DWR ID	DWR_NA0003_01_f_2018_33				
Comment Code					
A1 : Exterminate rodents and backfill and compact or grout burrows.					
Inspector Comment					
Repair the rodent holes along the landside slope.

View of the rodent holes along the landside slope.

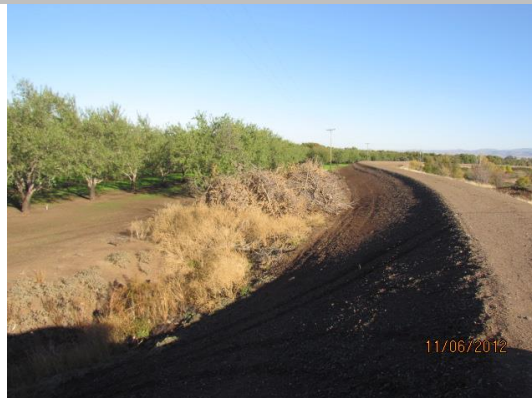
Photo 1 of 1 : FA\_2018\_NA0003\_64\_21\_20180905\_00004.jpg

LM Start	4.46	Rating **	M	Issue No.	21
LM End	4.46	Issue Type +	En	Location *	LS
Category	Earthen Levee			GPS Latitude/Longitude	
				Start	End
Item	Encroachments			39.775908 °	39.775908 °
				-121.893947 °	-121.893947 °
DWR ID	DWR_NA0003_01_s_2012_21				
Comment Code					
PR : Prunings					
Inspector Comment					
Remove the prunings from the landside slope.

View of the brush pile along landside toe.

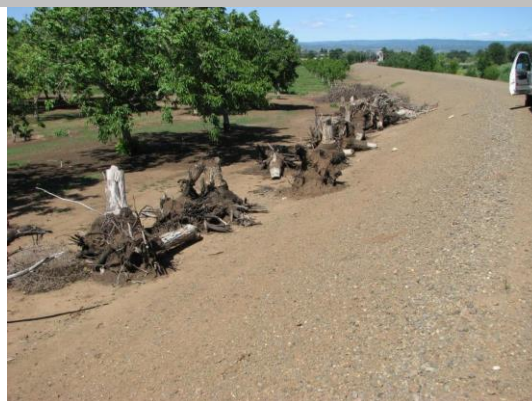
Photo 1 of 1 : FA\_2018\_NA0003\_64\_38\_20180905\_00019.jpg

LM Start	4.77	Rating **	M	Issue No.	38
LM End	4.79	Issue Type +	En	Location *	LS
Category	Earthen Levee			GPS Latitude/Longitude	
				Start	End
Item	Encroachments			39.779822 °	39.780062 °
				-121.891803 °	-121.891475 °
DWR ID	DWR_NA0003_01_s_2016_38				
Comment Code					
PR : Prunings					
Inspector Comment					
Remove the prunings from the landside slope.

View of prunings and stumps at the landside toe.

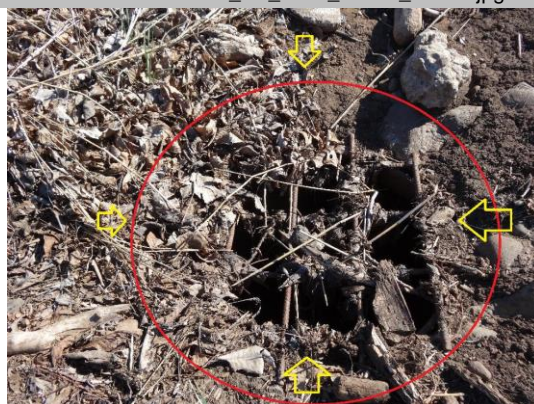
Photo 2 of 2 : UCIP\_FA\_2018\_30388\_55890.jpg

Comment Code						
Inspector Comment						
FS_ID:30388						
DS_ID:19221						
EP_NO: N/A						
Repair Type: Non-Urgent						
Crossing Status: Found						
UCIP Comments: CM Standpipe intake. Intake pipe with air vent. Steel rib-bar grit cover on the standpipe on landside levee toe.Needs cleaning and clearing on both ends of the pipe.						
FIELD_STRUCT_DESC: 24-inch corrugated metal gravity drainage pipe through the levee, 15 feet below the crown. Flap gate on the waterside (WS) end. Concrete U-shaped headwall on the WS end. Grouted riprap spillway on the WS end. Corrugated metal standpipe intake. Intake pipe with an air vent. Steel rib-bar grit cover on the standpipe on the landside (LS) toe. [Additional Reference(s): DWR Levee Log, 1992. USACE Sacramento O&M Manual 504, May 1965, (HLM 4.94)].						
FS Date: 2/20/2014

LS view: Underground CM standpipe intake with steel grit on levee toe.

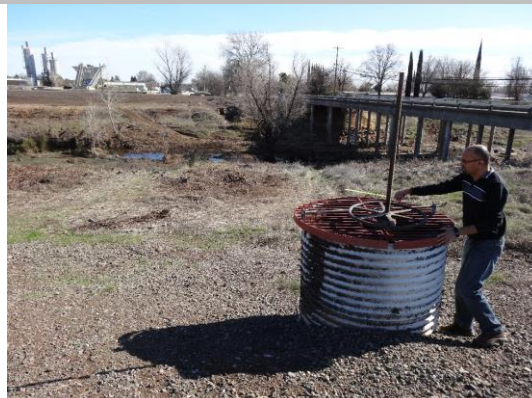
Photo 2 of 3 : UCIP\_FA\_2018\_30327\_55767.jpg

WS view: CM standpipe with slide gate on levee slope.

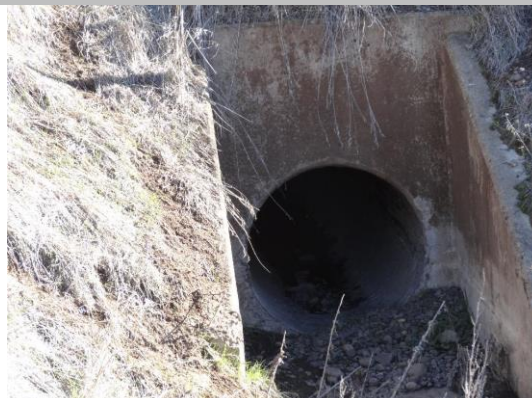
Photo 3 of 3 : UCIP\_FA\_2018\_30327\_55766.jpg

LS view: U type concrete headwall and CMP on levee slope.

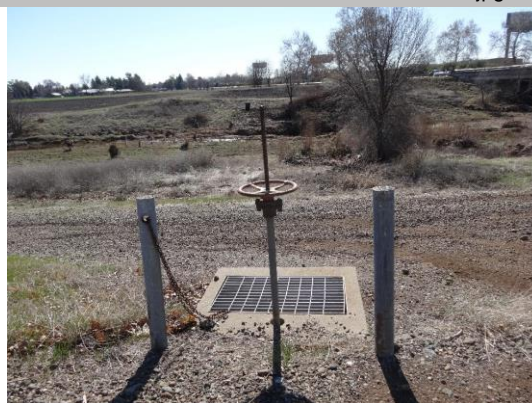
Photo 1 of 3 : UCIP\_FA\_2018\_30368\_55861.jpg

LM Start	5.30	Rating **	M	Issue No.	71
LM End	5.30	Issue Type +	En	Location *	
Category	Supplemental			GPS Latitude/Longitude	
				Start	End
Item	DWR UCIP Field Study			39.784739 °	39.784739 °
				-121.884860 °	-121.884860 °
DWR ID	19223				
Comment Code					
Inspector Comment					
FS_ID:30368					
DS_ID:19223					
EP_NO: N/A					
Repair Type: Non-Urgent					
Crossing Status: Found					
UCIP Comments: 12-inch steel pipe about 14 ft below the crown.					
FIELD_STRUCT_DESC: 12-inch steel drainage discharge pipeline					
through the levee, 14 feet below the crown. Slide gate in a concrete box					
on the waterside (WS) slope. Flap gate on the WS end. Grouted rock					
revetment on the WS slope. Three pumps on a concrete pad on the					
landside (LS). [Additional Reference(s): DWR Levee Log, 1992, 18-inch					
pipe referenced, 1 foot below the crown].					
FS Date: 2/24/2014

WS view: slide gate in concrete box on levee slope.

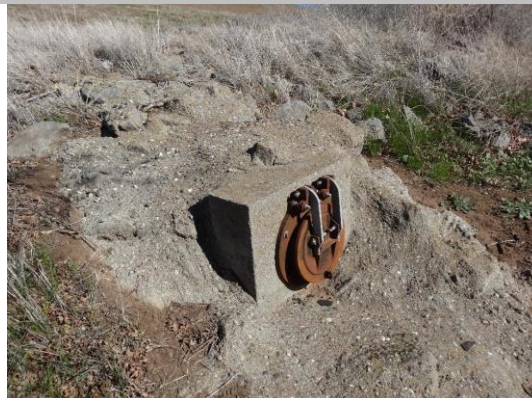
Photo 2 of 3 : UCIP\_FA\_2018\_30368\_55860.jpg

WS view: concrete headwall and flapgate on levee slope.

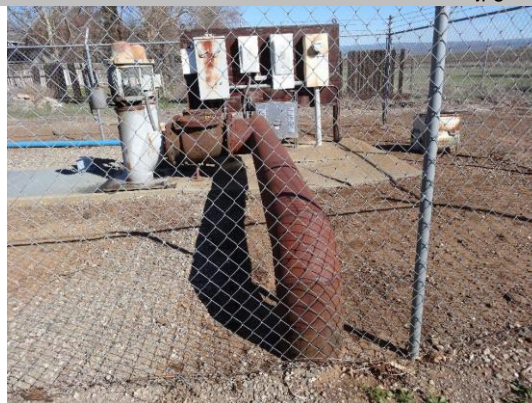
Photo 3 of 3 : UCIP\_FA\_2018\_30368\_55859.jpg

LS view: pipe, pumps, power boxes, concrete vault on landside.

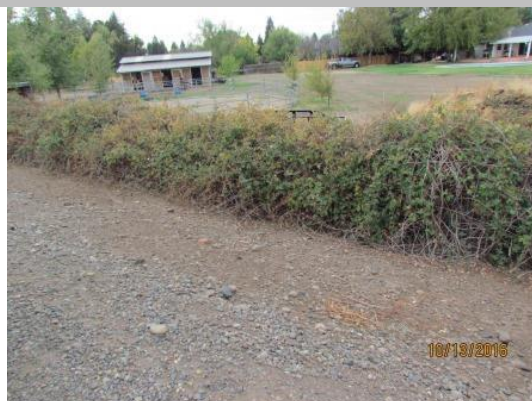
Photo 1 of 1 : FA\_2018\_NA0003\_64\_22\_20180905\_00005.jpg

LM Start	5.96	Rating **	M	Issue No.	22
LM End	5.96	Issue Type +	Ma	Location *	LS
Category	Earthen Levee			GPS Latitude/Longitude	
				Start	End
Item	Vegetation			39.793116 °	39.793116 °
				-121.887296 °	-121.887296 °
DWR ID	DWR_NA0003_01_f_2016_22				
Comment Code					
V4 : Elderberries are blocking visibility and flood fight capability.					
Inspector Comment					
Blackberry bramble

View of the blackberries blocking visibility and access.

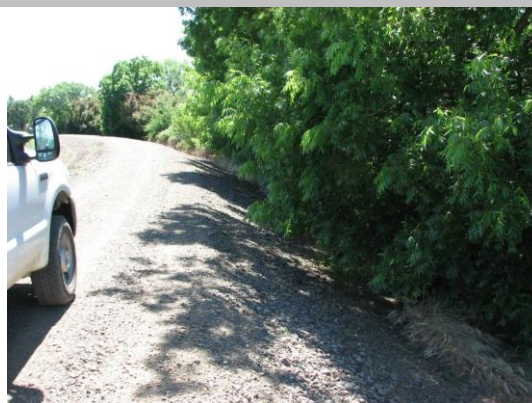
Photo 1 of 1 : FA\_2018\_NA0003\_64\_37\_20180905\_00018.jpg

LM Start	5.98	Rating **	U	Issue No.	37
LM End	6.07	Issue Type +	Ma	Location *	LS
Category	Earthen Levee			GPS Latitude/Longitude	
				Start	End
Item	Vegetation			39.793411 °	39.794580 °
				-121.887310 °	-121.886759 °
DWR ID	DWR_NA0003_01_s_2016_37				
Comment Code					
V7 : Trees / Woody Vegetation					
Inspector Comment					
Various overgrown vegetation completely obscuring landside toe visibility.

04/25/2016: Trim trees on L/S slope.

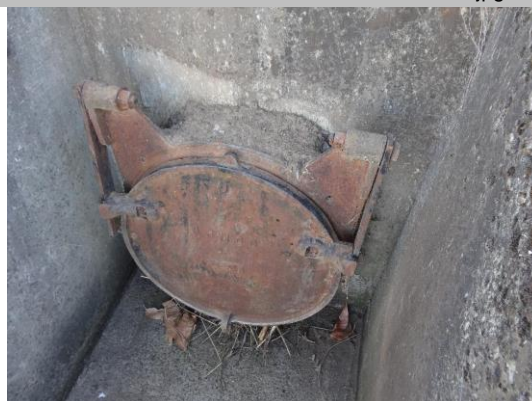
Photo 1 of 3 : UCIP\_FA\_2018\_30403\_55922.jpg

LM Start	1.26	Rating **	M	Issue No.	44
LM End	1.26	Issue Type +	Ma	Location *	
Category	Supplemental			GPS Latitude/Longitude	
				Start	End
Item	DWR UCIP LMA Responsibility			39.784062 °	39.784062 °
				-121.884344 °	-121.884344 °
DWR ID	19235				
Comment Code					
Inspector Comment					
FS_ID:30403 DS_ID:19235 EP_NO: N/A Repair Type: Non-Urgent Crossing Status: Found UCIP Comments: Needs cleaning and clearing of debris. FIELD_STRUCT_DESC: 24-inch corrugated metal gravity drainage pipe through the levee, 12.5 feet below the crown. Flap gate on the waterside (WS) end. Concrete U-shaped headwall on each end. Grouted riprap apron on the landside (LS) end. Grouted riprap spillway on the WS end. [Additional Reference(s): DWR Levee Log, 1992. USACE Sacramento O&M Manual 504, May 1965, (HLM 1.34)]. FS Date: 2/24/2014

WS view: U type concrete headwall, pipe, and flapgate on levee slope.

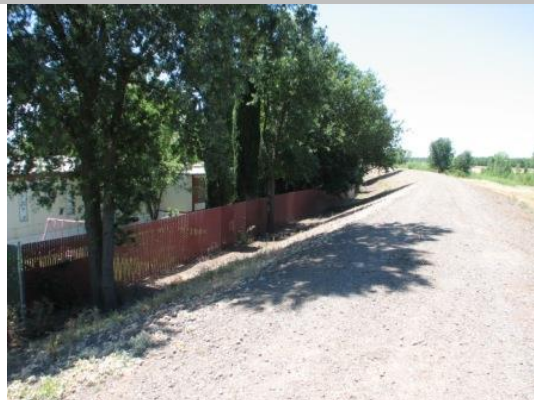
Photo 1 of 1 : FA\_2018\_NA0003\_65\_3\_20180905\_00002.jpg

LM Start	1.49	Rating **	U	Issue No.	3
LM End	1.81	Issue Type +	En	Location *	LS
Category	Earthen Levee			GPS Latitude/Longitude	
				Start	End
Item	Encroachments			39.782773 °	39.778972 °
				-121.888178 °	-121.891563 °
DWR ID	DWR_NA0003_02_s_2012_3				
Comment Code					
FE : Fence					
Inspector Comment					
The fence is within the easement.

View of the fence along the landside toe of the levee.

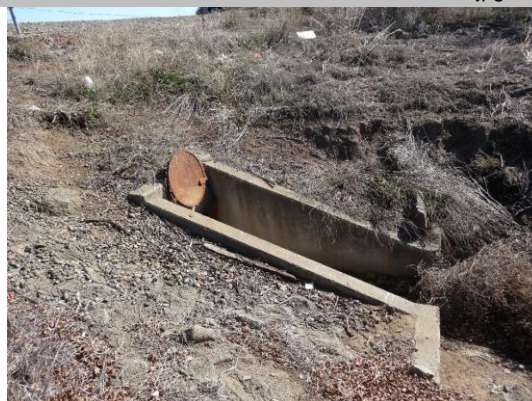
Photo 1 of 3 : UCIP\_FA\_2018\_41375\_56646.jpg

Comment Code					
Inspector Comment					
FS_ID:41375 DS_ID:19238 EP_NO: 12619A Repair Type: Non-Urgent Crossing Status: Found UCIP Comments: - 24-inch CM pipe.- inlet and spillway may need cleaning and clearing. FIELD_STRUCT_DESC: 24-inch corrugated metal gravity storm drainage pipe through the levee, 11 feet below the crown. Flap gate on the waterside (WS) end. Concrete U-shaped headwall on each end. Grouted riprap apron on the landside (LS) end. Grouted riprap spillway on the WS end. (Plans to replace an existing 24-inch storm drain inlet to the Mud Creek Diversion Channel with a 36-inch storm drain located approximately 500 feet upstream from Nord Highway authorized under Permit No. 12619, 1979 - Richard E. Vermillion. Plans for extension of time to replace an existing 24-inch storm drain inlet to the Mud Creek Diversion Channel with a 36-inch storm drain located upstream from Nord Highway authorized under Permit No. 12619-A, 1980 - Richard E. Vermillion). The storm drain never got replaced. [Additional Reference(s): DWR Levee Log, 1992, 36-inch pipe referenced. USACE Sacramento O&M Manual 504, May 1965, (HLM 2.13)]. FS Date: 2/24/2014

WS view: U type concrete headwall and flapgate on levee slope. Vegetation debris on spillway.

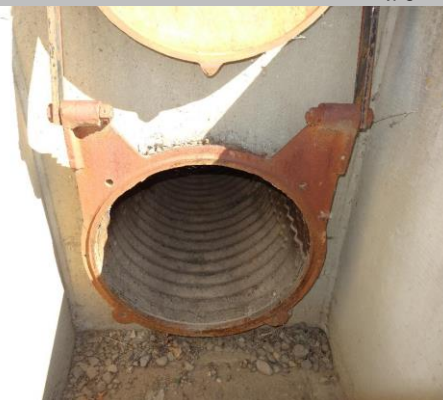
Photo 2 of 3 : UCIP\_FA\_2018\_41375\_56645.jpg

WS view: U type concrete headwall, pipe, and flapgate on levee slope.

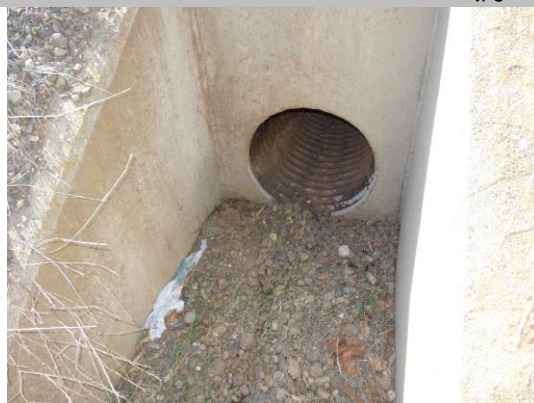
Photo 3 of 3 : UCIP\_FA\_2018\_41375\_56644.jpg

LS view: U type concrete headwall and CMP on levee slope.

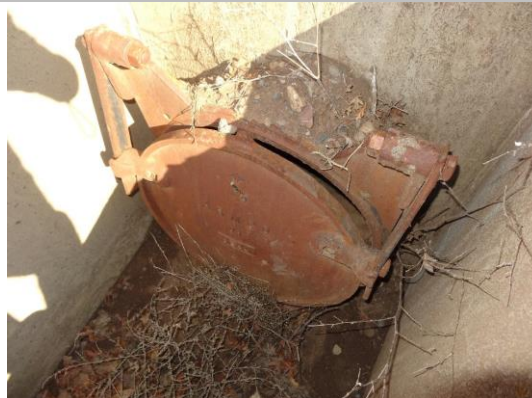
Photo 1 of 3 : UCIP\_FA\_2018\_30783\_56682.jpg

LM Start	2.74	Rating **	M	Issue No.	49
LM End	2.74	Issue Type +	Ma	Location *	
Category	Supplemental			GPS Latitude/Longitude	
				Start	End
Item	DWR UCIP LMA Responsibility			39.768741 °	39.768741 °
				-121.901176 °	-121.901176 °
DWR ID	19240				
Comment Code					
Inspector Comment					
FS_ID:30783 DS_ID:19240 EP_NO: N/A Repair Type: Non-Urgent Crossing Status: Found UCIP Comments: Needs cleaning and clearing of debris. FIELD_STRUCT_DESC: 24-inch corrugated metal gravity drainage pipe through the levee, 10 feet below the crown. Flap gate on the waterside (WS) end. Concrete U-shaped headwall on each end. Grouted riprap apron on the landside (LS) end. Grouted riprap spillway on the WS end. [Additional Reference(s): DWR Levee Log, 1992. USACE Sacramento O&M Manual 504, May 1965, (HLM 2.86)]. FS Date: 2/24/2014

WS view: U type concrete headwall, pipe, and flapgate on levee slope. Gate not fully closed. Debris and soil in outlet box.

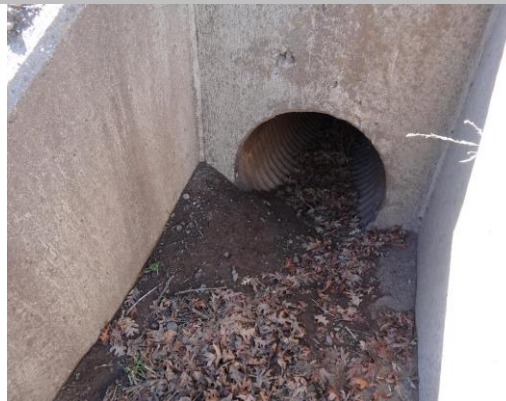
Photo 2 of 3 : UCIP\_FA\_2018\_30783\_56681.jpg

LS view: U type concrete headwall and CMP on levee slope. Debris and soil in inlet box.

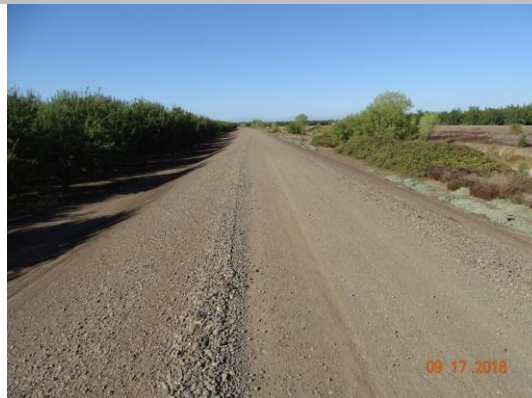
Photo 1 of 1 : FA\_2018\_NA0003\_65\_26\_20181001\_00067.jpg

LM Start	2.91	Rating **	A	Issue No.	26	
LM End	2.91	Issue Type +	Ma	Location *	LS	
Category	Earthen Levee			GPS Latitude/Longitude		
				Start		End
Item	Vegetation			39.766620 °		39.766620 °
				-121.902605 °		-121.902605 °
DWR ID	DWR_NA0003_02_f_2018_26					
Comment Code						
V1 : Control annual grass and weeds on the levee slopes and easements.						
Inspector Comment						
The vegetation was removed on both slopes.

View of no vegetation on both slopes.

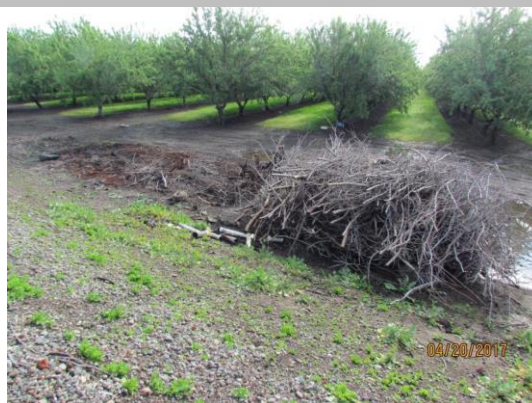
Photo 1 of 1 : FA\_2018\_NA0003\_65\_5\_20180905\_00003.jpg

LM Start	3.31	Rating **	M	Issue No.	5
LM End	3.31	Issue Type +	En	Location *	LS
Category	Earthen Levee			GPS Latitude/Longitude	
				Start	End
Item	Encroachments			39.763208 °	39.763208 °
				-121.908517 °	-121.908517 °
DWR ID	DWR_NA0003_02_f_2012_5				
Comment Code					
PR : Prunings					
Inspector Comment

View of the prunings along the landside toe.

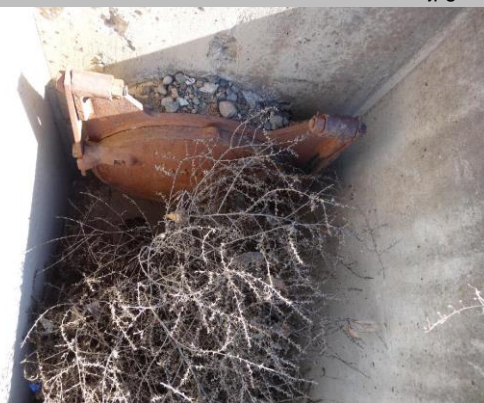
Photo 1 of 3 : UCIP\_FA\_2018\_30803\_56685.jpg

LM Start	3.50	Rating **	M	Issue No.	50
LM End	3.50	Issue Type +	Ma	Location *	
Category	Supplemental			GPS Latitude/Longitude	
				Start	End
Item	DWR UCIP LMA Responsibility			39.760847 °	39.760847 °
				-121.910265 °	-121.910265 °
DWR ID	19241				
Comment Code					
Inspector Comment					
FS_ID:30803 DS_ID:19241 EP_NO: N/A Repair Type: Non-Urgent Crossing Status: Found UCIP Comments: Needs cleaning and clearing of debris. FIELD_STRUCT_DESC: 24-inch corrugated metal gravity drainage pipe through the levee, 6.5 feet below the crown. Flap gate on the waterside (WS) end. Concrete U-shaped headwall on each end. Grouted riprap apron on the landside (LS) end. Grouted riprap spillway on the WS end. [Additional Reference(s): DWR Levee Log, 1992. USACE Sacramento O&M Manual 504, May 1965, (HLM 3.64)]. FS Date: 2/24/2014

WS view: U type concrete headwall, pipe, and flapgate on levee slope. Vegetation debris and soil blocking outlet.

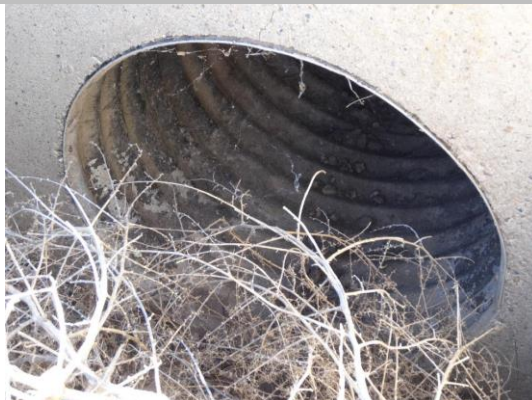
Photo 3 of 3 : UCIP\_FA\_2018\_30803\_56683.jpg

LS view: inside view of CMP on levee slope. Needs cleaning and clearing.

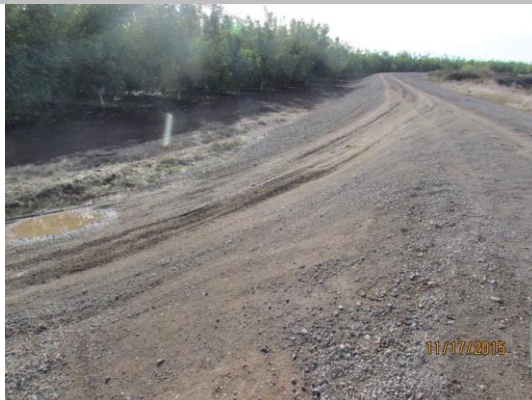
Photo 1 of 1 : FA\_2018\_NA0003\_65\_10\_20180905\_00005.jpg

View of the vehicle erosion along the landside slope.

LM Start	3.52	Rating **	M	Issue No.	10
LM End	3.52	Issue Type +	Ma	Location *	LS
Category	Earthen Levee			GPS Latitude/Longitude	
				Start	End
Item	Slope Stability			39.760582 °	39.760582 °
				-121.910303 °	-121.910303 °
DWR ID	DWR_NA0003_02_f_2015_10				
Comment Code					
S3 : Repair the levee slope damaged by vehicle traffic and prevent access where possible.					
Inspector Comment

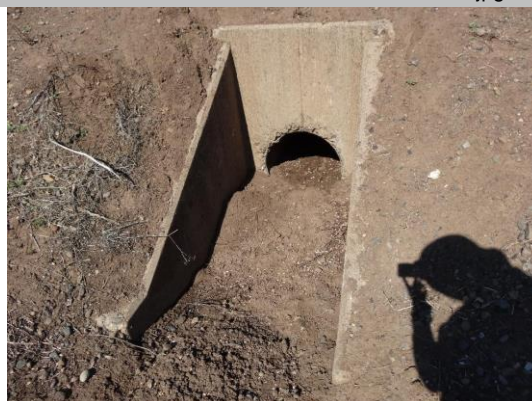
Photo 2 of 3 : UCIP\_FA\_2018\_31031\_56916.jpg

LM Start	5.64	Rating **	M	Issue No.	52 (cont)	
LM End	5.64	Issue Type +	Ma	Location *		
Category	Supplemental			GPS Latitude/Longitude		
				Start	End	
Item	DWR UCIP LMA Responsibility			39.738898 °	39.738898 °	
				-121.930242 °	-121.930242 °	
DWR ID	19247					
Comment Code						
Inspector Comment						
FS_ID:31031 DS_ID:19247 EP_NO: N/A Repair Type: Non-Urgent Crossing Status: Found UCIP Comments: Needs cleaning and clearing of debris. FIELD_STRUCT_DESC: 24-inch corrugated metal gravity drainage pipe through the levee, 11.5 feet below the crown. Flap gate on the waterside (WS) end. Concrete U-shaped headwall on each end. Grouted riprap apron on the landside (LS) end. Grouted riprap spillway on the WS end. [Additional Reference(s): DWR Levee Log, 1992. USACE Sacramento O&M Manual 504, May 1965, (HLM 5.83)]. FS Date: 2/25/2014

LS view: U type concrete headwall and CMP on levee slope. Soil/mud on inlet box.

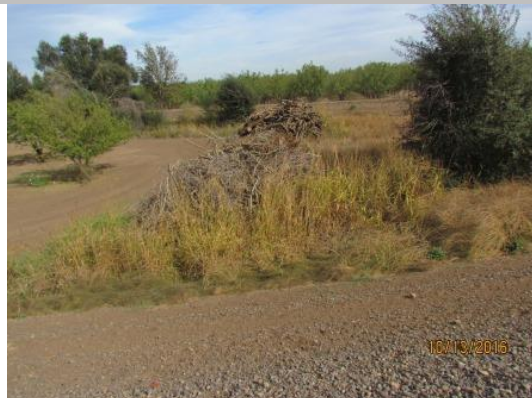
Photo 1 of 1 : FA\_2018\_NA0003\_65\_35\_20180905\_00009.jpg

LM Start	6.07	Rating **	M	Issue No.	35
LM End	6.07	Issue Type +	En	Location *	LS
Category	Earthen Levee			GPS Latitude/Longitude	
				Start	End
Item	Encroachments			39.733583 °	39.733583 °
				-121.930511 °	-121.930511 °
DWR ID	DWR_NA0003_02_f_2016_35				
Comment Code					
PR : Prunings					
Inspector Comment					
Remove prunings from the landside toe.

View of the prunings along the landside toe.

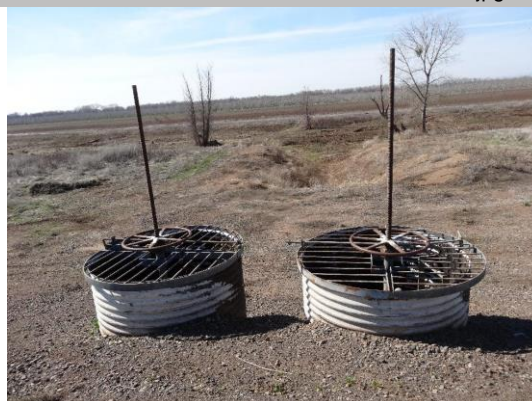
Photo 1 of 3 : UCIP\_FA\_2018\_41376\_56920.jpg

Comment Code						
Inspector Comment						
FS_ID:41376 DS_ID:19248 EP_NO: N/A Repair Type: Non-Urgent Crossing Status: Found UCIP Comments: Needs cleaning and clearing of debris. FIELD_STRUCT_DESC: [Channel Slough Drainage Structure] 1 of 2: 42-inch corrugated metal gravity drainage pipe through the levee, 16 feet below the crown. Flap gate on the waterside (WS) end. Slide gate in a corrugated metal pipe (CMP) riser on the WS slope. Concrete U-shaped headwall on each end. Grouted riprap apron and rock revetment on the landside (LS) end. [Additional Reference(s): DWR Levee Log, 1992. USACE Sacramento O&M Manual 504, May 1965, (HLM 6.30)]. FS Date: 2/25/2014

WS view: slide gates in CMP risers on levee slope.

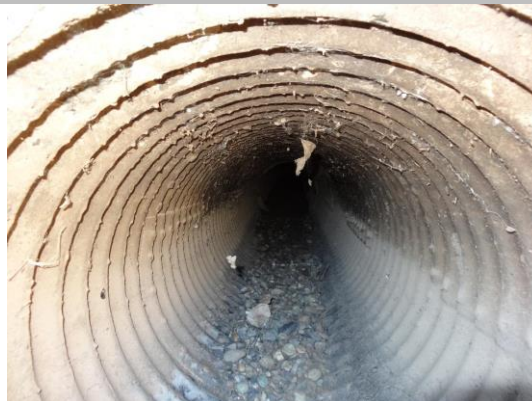
Photo 3 of 3 : UCIP\_FA\_2018\_31034\_56924.jpg

LS view: inside view of CMP on levee slope. Needs cleaning and clearing.

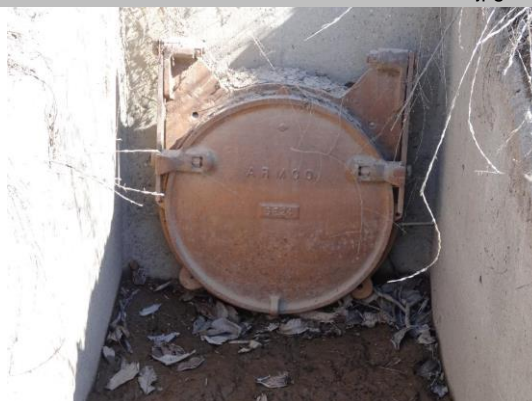
Photo 1 of 3 : UCIP\_FA\_2018\_31085\_56988.jpg

LM Start	6.43	Rating **	M	Issue No.	56
LM End	6.43	Issue Type +	Ma	Location *	
Category	Supplemental			GPS Latitude/Longitude	
				Start	End
Item	DWR UCIP LMA Responsibility			39.728812 °	39.728812 °
				-121.932623 °	-121.932623 °
DWR ID	19251				
Comment Code					
Inspector Comment					
FS_ID:31085 DS_ID:19251 EP_NO: N/A Repair Type: Non-Urgent Crossing Status: Found UCIP Comments: Needs cleaning and clearing of debris. FIELD_STRUCT_DESC: 24-inch corrugated metal gravity drainage pipe through the levee, 15.5 feet below the crown. Flap gate on the waterside (WS) end. Concrete U-shaped headwall on each end. Grouted riprap apron on the landside (LS) end. Grouted riprap spillway on the WS end. [Additional Reference(s): DWR Levee Log, 1992. USACE Sacramento O&M Manual 504, May 1965, (HLM 6.65)]. FS Date: 2/25/2014

WS view: U type concrete headwall, pipe, and flapgate on levee slope. Soil/mud on outlet box.

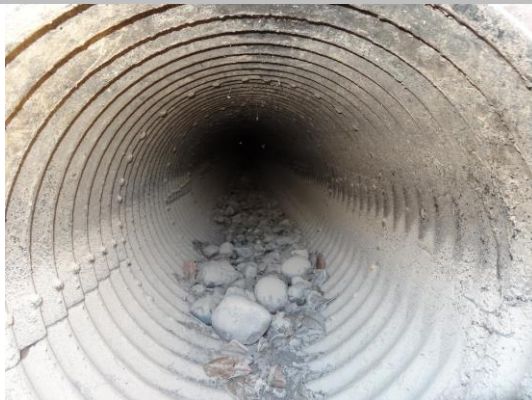
Photo 3 of 3 : UCIP\_FA\_2018\_31085\_56986.jpg

LS view: inside view of CMP on levee slope. Needs cleaning and clearing.

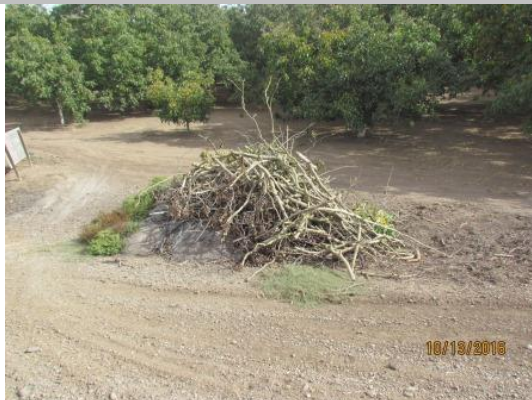
Photo 1 of 1 : FA\_2018\_NA0003\_65\_37\_20180905\_00010.jpg

LM Start	6.44	Rating **	M	Issue No.	37
LM End	6.44	Issue Type +	En	Location *	LS
Category	Earthen Levee			GPS Latitude/Longitude	
				Start	End
Item	Encroachments			39.728779 °	39.728779 °
				-121.932679 °	-121.932679 °
DWR ID	DWR_NA0003_02_f_2016_37				
Comment Code					
PR : Prunings					
Inspector Comment					
Remove prunings from the landside toe.

View of the prunings along the landside toe.

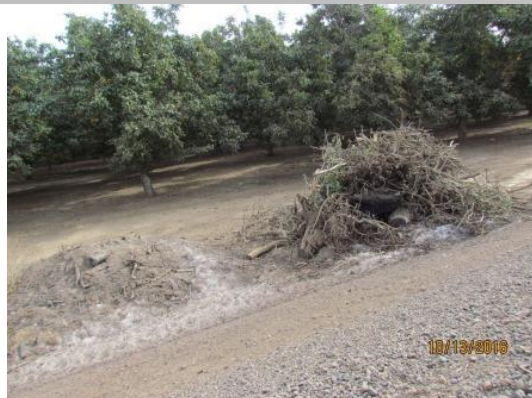
Photo 1 of 1 : FA\_2018\_NA0003\_65\_38\_20180905\_00011.jpg

LM Start	6.71	Rating **	M	Issue No.	38
LM End	6.71	Issue Type +	En	Location *	LS
Category	Earthen Levee			GPS Latitude/Longitude	
				Start	End
Item	Encroachments			39.725695 °	39.725695 °
				-121.935791 °	-121.935791 °
DWR ID	DWR_NA0003_02_f_2016_38				
Comment Code					
PR : Prunings					
Inspector Comment					
Remove prunings from the landside toe.

View of the prunings along the landside toe.

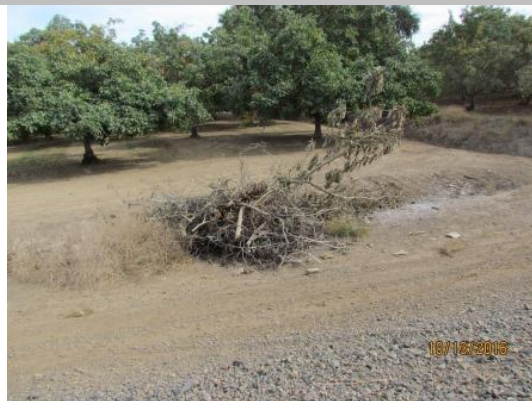
Photo 1 of 1 : FA\_2018\_NA0003\_65\_39\_20180905\_00012.jpg

LM Start	6.92	Rating **	M	Issue No.	39
LM End	6.92	Issue Type +	En	Location *	LS
Category	Earthen Levee			GPS Latitude/Longitude	
				Start	End
Item	Encroachments			39.723014 °	39.723014 °
				-121.937819 °	-121.937819 °
DWR ID	DWR_NA0003_02_f_2016_39				
Comment Code					
PR : Prunings					
Inspector Comment					
Remove prunings from the landside toe.

View of the prunings along the landside toe.

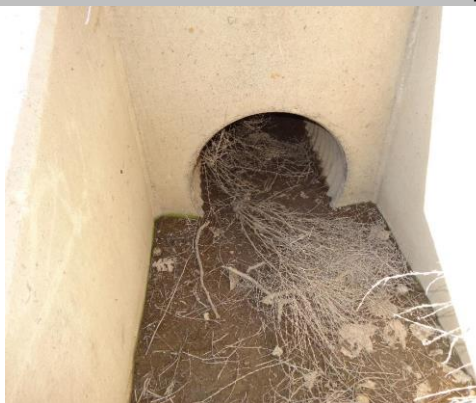
Photo 2 of 3 : UCIP\_FA\_2018\_31103\_57001.jpg

LS view: U type concrete headwall and CMP on levee slope. Soil/mud on inlet box.

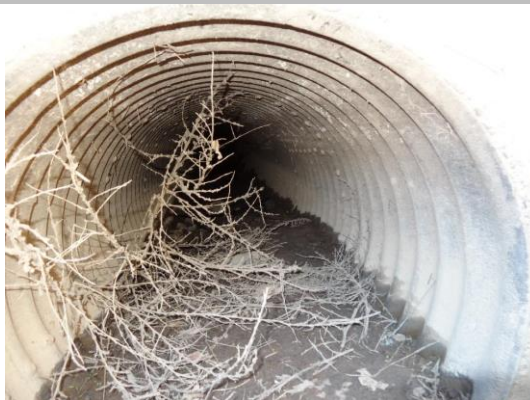
Photo 3 of 3 : UCIP\_FA\_2018\_31103\_57000.jpg

LS view: inside view of CMP on levee slope. Needs cleaning and clearing.

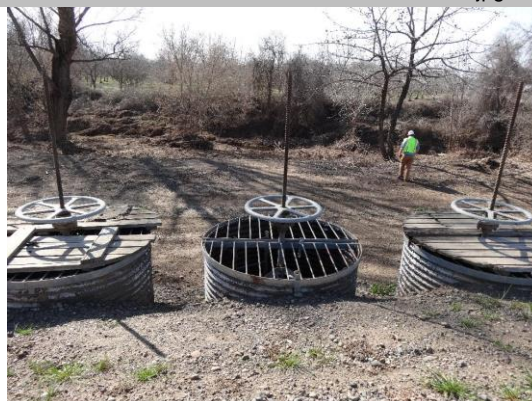
Photo 1 of 3 : UCIP\_FA\_2018\_32085\_58585.jpg

Comment Code						
Inspector Comment						
FS_ID:32085 DS_ID:19253 EP_NO: N/A Repair Type: Non-Urgent Crossing Status: Found UCIP Comments: Slide gates in CMP risers on waterside shoulder.Needs cleaning and clearing of debris. FIELD_STRUCT_DESC: 1 of 3: 48-inch corrugated metal gravity drainage pipe through the levee, 18 feet below the crown. Flap gate on the waterside (WS) end. Slide gate in a corrugated metal pipe (CMP) riser on the WS shoulder. Concrete U-shaped headwall on each end. Grouted riprap apron on the landside (LS) end. Grouted riprap spillway on the WS end. [Additional Reference(s): DWR Levee Log, 1992. USACE Sacramento O&M Manual 504, May 1965, (HLM 7.46)]. FS Date: 2/25/2014

WS view: slide gates in CMP risers on waterside shoulder.

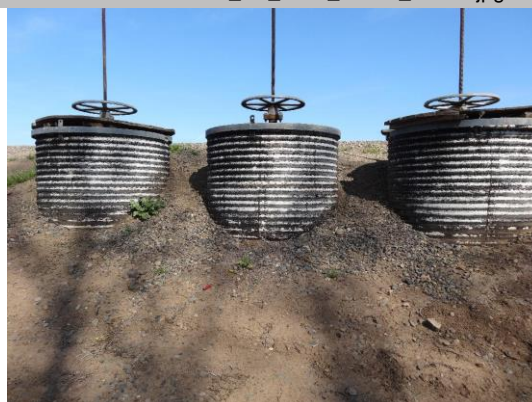
Photo 1 of 3 : UCIP\_FA\_2018\_32087\_58592.jpg

Comment Code					
Inspector Comment					
FS_ID:32087 DS_ID:19261 EP_NO: N/A Repair Type: Non-Urgent Crossing Status: Found UCIP Comments: Slide gates in CMP risers on waterside shoulder.Needs cleaning and clearing on both pipe ends. FIELD_STRUCT_DESC: 3 of 3: 48-inch corrugated metal gravity drainage pipe through the levee, 18 feet below the crown. Flap gate on the waterside (WS) end. Slide gate in a corrugated metal pipe (CMP) riser on the WS shoulder. Concrete U-shaped headwall on each end. Grouted riprap apron on the landside (LS) end. Grouted riprap spillway on the WS end. [Additional Reference(s): DWR Levee Log, 1992. USACE Sacramento O&M Manual 504, May 1965, (HLM 7.46)]. FS Date: 2/25/2014

WS view: slide gates in CMP risers on waterside shoulder.

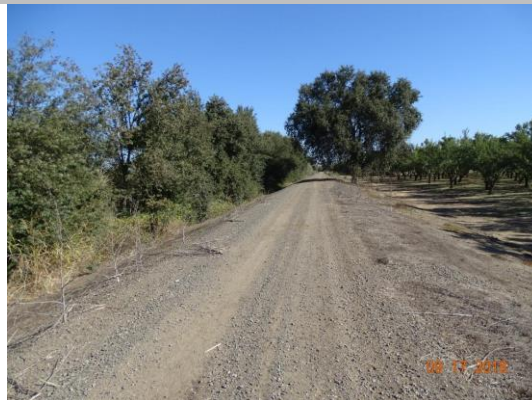
Photo 1 of 1 : FA\_2018\_NA0003\_66\_3\_20181001\_00001.jpg

LM Start	0.05	Rating **	A	Issue No.	3
LM End	0.05	Issue Type +	Ma	Location *	LS
Category	Earthen Levee			GPS Latitude/Longitude	
				Start	End
Item	Vegetation			39.733567 °	39.733567 °
				-121.929850 °	-121.929850 °
DWR ID	DWR_NA0003_02A_f _ 2018_3				
Comment Code					
V1 : Control annual grass and weeds on the levee slopes and easements.					
Inspector Comment					
The vegetation was removed from both slopes.

View of no vegetation on both slopes.

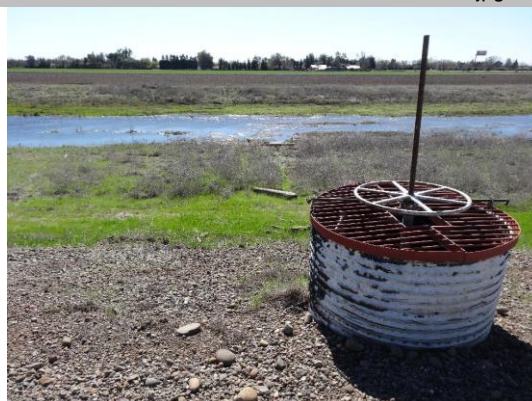
Photo 3 of 3 : UCIP\_FA\_2018\_51844\_58600.jpg

Comment Code						
Inspector Comment						
FS_ID:51844 DS_ID:19262 EP_NO: N/A Repair Type: No Action Needed Crossing Status: Found UCIP Comments: 05/16/2017 Crossing has been downgraded from Non-Urgent to No Action Needed. The flap gate appears to be in good working order based on the photos, and the small pile of debris not enough to warrant Non-Urgent rating. (K. Fazel - UCIP)03/11/2014:Slide gate in CMP riser on waterside.The culvert was working during field inspection. (P. Amatya - DWR) FIELD_STRUCT_DESC: 42-inch corrugated metal gravity drainage pipe through the levee, 14 feet below the crown. Flap gate on the waterside (WS) end. Slide gate in a corrugated metal pipe (CMP) riser on the WS slope. Concrete U-shaped headwall on each end. Grouted riprap apron on the landside (LS) end. Grouted riprap spillway on the WS end. [Additional Reference(s): DWR Levee Log, 1992. USACE Sacramento O&M Manual 504, May 1965, (HLM 0.09)]. FS Date: 3/11/2014

WS view: slide gate in CMP riser on waterside shoulder.

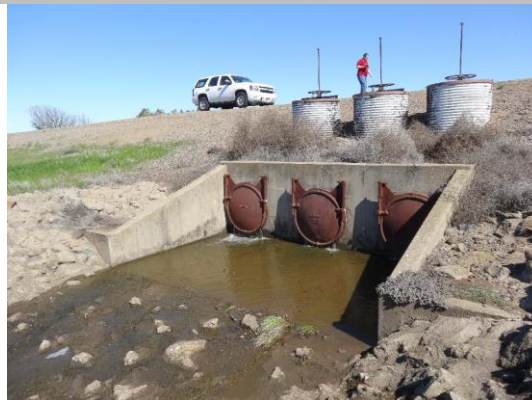
Photo 1 of 2 : UCIP\_FA\_2018\_32104\_58606.jpg

Comment Code						
Inspector Comment						
FS_ID:32104						
DS_ID:19278						
EP_NO: N/A						
Repair Type: No Action Needed						
Crossing Status: Found						
UCIP Comments: Slide gate in CMP riser on waterside.The culvert was working during the field visit.						
FIELD_STRUCT_DESC: 1 of 3: 48-inch corrugated metal gravity drainage pipe through the levee, 11.7 feet below the crown. Slide gate in a riser well on the waterside (WS) slope. Concrete U-shaped headwall on each end. Flap gate on the WS end. Grouted riprap outlet channel on the WS. [Additional Reference(s): DWR Levee Log, 1992. USACE Sacramento O&M Manual 504, May 1965, (HLM 0.39)].						
FS Date: 3/11/2014

WS view: U type concrete headwall and three CMPs with slide gates on levee slope. Grouted riprap spillway.

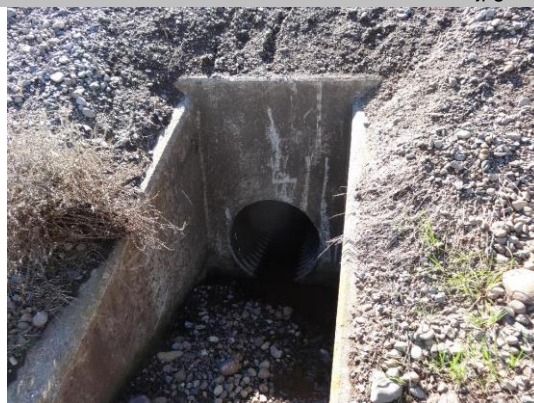
Photo 3 of 3 : UCIP\_FA\_2018\_32107\_58611.jpg

LM Start	1.25	Rating **	A/W	Issue No.	28 (cont)	
LM End	1.25	Issue Type +	Ma	Location *		
Category	Supplemental			GPS Latitude/Longitude		
				Start	End	
Item	DWR UCIP LMA Responsibility			39.779678 °	39.779678 °	
				-121.862632 °	-121.862632 °	
DWR ID	19264					
Comment Code						
Inspector Comment						
FS_ID:32107						
DS_ID:19264						
EP_NO: N/A						
Repair Type: No Action Needed						
Crossing Status: Found						
UCIP Comments: The culvert was working during the field visit.						
FIELD_STRUCT_DESC: 24-inch corrugated metal gravity drainage pipe						
through the levee, 11.7 feet below the crown. Flap gate on the						
waterside (WS) end. Concrete U-shaped headwall on each end.						
[Additional Reference(s): DWR Levee Log, 1992. USACE Sacramento						
O&M Manual 504, May 1965, (HLM 1.28)].						
FS Date: 3/11/2014

LS view: U type concrete headwall and CMP on levee slope.

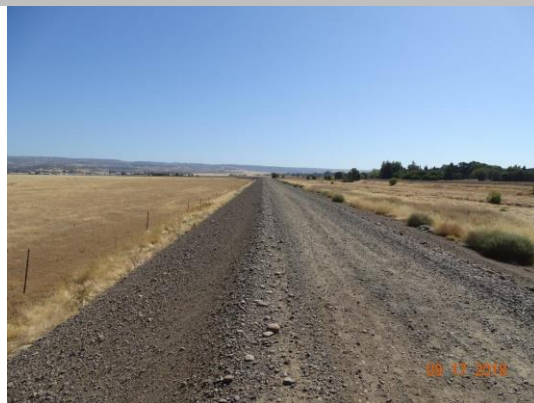
Photo 1 of 1 : FA\_2018\_NA0003\_67\_22\_20181001\_00039.jpg

LM Start	1.33	Rating **	A	Issue No.	22
LM End	1.33	Issue Type +	Ma	Location *	LS
Category	Earthen Levee			GPS Latitude/Longitude	
				Start	End
Item	Vegetation			39.779420 °	39.779420 °
				-121.861140 °	-121.861140 °
DWR ID	DWR_NA0003_03_f_2018_22				
Comment Code					
V1 : Control annual grass and weeds on the levee slopes and easements.					
Inspector Comment					
The vegetation was removed from both slopes.

View of no vegetation on both slopes.

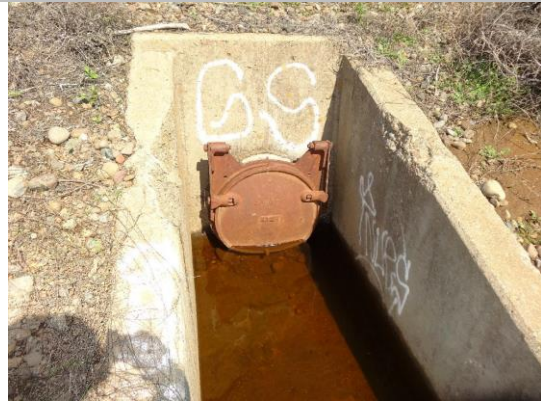
Photo 1 of 2 : UCIP\_FA\_2018\_31899\_58187.jpg

LM Start	1.50	Rating **	A/W	Issue No.	29	
LM End	1.50	Issue Type +	Ma	Location *		
Category	Supplemental			GPS Latitude/Longitude		
				Start	End	
Item	DWR UCIP LMA Responsibility			39.779230 °	39.779230 °	
				-121.857945 °	-121.857945 °	
DWR ID	19265					
Comment Code						
Inspector Comment						
FS_ID:31899 DS_ID:19265 EP_NO: N/A Repair Type: No Action Needed Crossing Status: Found UCIP Comments: Working during the field visit. FIELD_STRUCT_DESC: 24-inch corrugated metal gravity drainage pipe through the levee, 11 feet below the crown. Flap gate on the waterside (WS) end. Concrete U-shaped headwall on each end. Grouted riprap apron on each end. [Additional Reference(s): DWR Levee Log, 1992. USACE Sacramento O&M Manual 504, May 1965, (HLM 1.53)]. FS Date: 3/11/2014

WS view: U type concrete headwall, flapgate, and CMP on levee slope. Looks clean and clear.

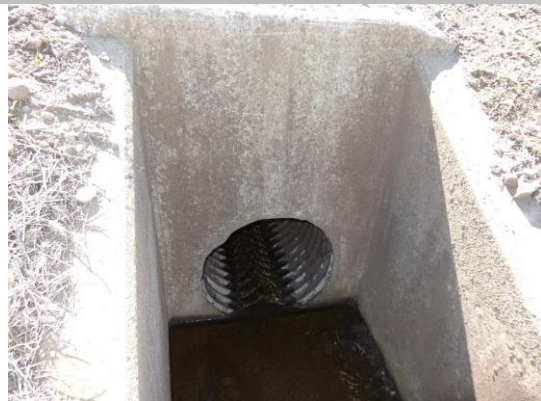
Photo 2 of 2 : UCIP\_FA\_2018\_31899\_58186.jpg

LS view: U type concrete headwall and CMP on levee slope. Looks clean and clear.

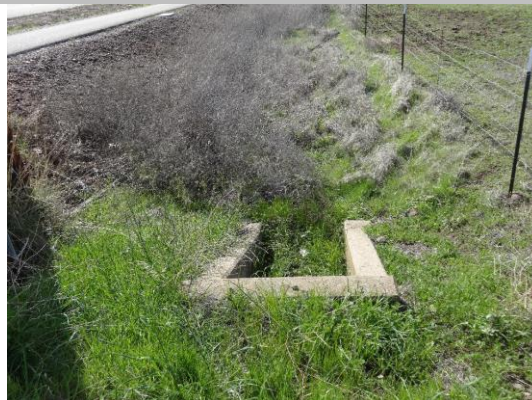
Photo 2 of 3 : UCIP\_FA\_2018\_32124\_58624.jpg

LM Start	2.17	Rating **	M	Issue No.	31 (cont)	
LM End	2.17	Issue Type +	Ma	Location *		
Category	Supplemental			GPS Latitude/Longitude		
				Start		End
Item	DWR UCIP LMA Responsibility			39.785290 °		39.785290 °
				-121.844235 °		-121.844235 °
DWR ID	19267					
Comment Code						
Inspector Comment						
FS_ID:32124 DS_ID:19267 EP_NO: N/A Repair Type: Non-Urgent Crossing Status: Found UCIP Comments: Pipe is about 4 feet below the crown. Needs cleaning and clearing the culvert. FIELD_STRUCT_DESC: 24-inch corrugated metal gravity drainage pipe through the levee, 6 feet below the crown. Flap gate on the waterside (WS) end. Concrete U-shaped headwall on each end. [Additional Reference(s): DWR Levee Log, 1992. USACE Sacramento O&M Manual 504, May 1965, (HLM 2.23)]. FS Date: 3/7/2014

LS view: U type concrete headwall of CMP culvert on levee slope. Vegetation on inlet box.

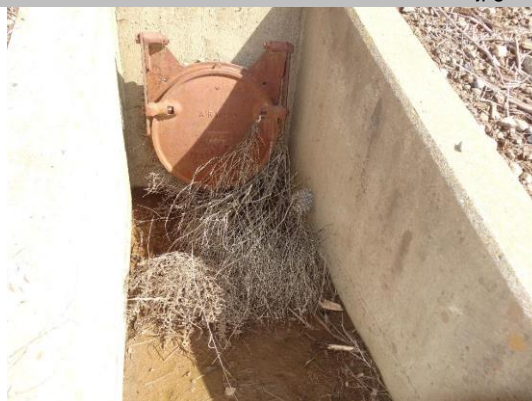
Photo 1 of 3 : UCIP\_FA\_2018\_31901\_58194.jpg

LM Start	3.08	Rating **	M	Issue No.	33
LM End	3.08	Issue Type +	Ma	Location *	
Category	Supplemental			GPS Latitude/Longitude	
				Start	End
Item	DWR UCIP LMA Responsibility			39.778016 °	39.778016 °
				-121.854460 °	-121.854460 °
DWR ID	19269				
Comment Code					
Inspector Comment					
FS_ID:31901 DS_ID:19269 EP_NO: N/A Repair Type: Non-Urgent Crossing Status: Found UCIP Comments: Needs cleaning and clearing the culvert. FIELD_STRUCT_DESC: 24-inch corrugated metal gravity drainage pipe through the levee, 11 feet below the crown. Flap gate on the waterside (WS) end. Concrete U-shaped headwall on each end. Grouted riprap apron on the landside (LS) end. Grouted riprap spillway on the WS end. [Additional Reference(s): DWR Levee Log, 1992. USACE Sacramento O&M Manual 504, May 1965, (HLM 3.16)]. FS Date: 3/7/2014

WS view: U type concrete headwall, flapgate, and CMP on levee slope. Needs cleaning and clearing.
